Penycae Conservation Area Assessment and Management Plan

Adopted June 2011

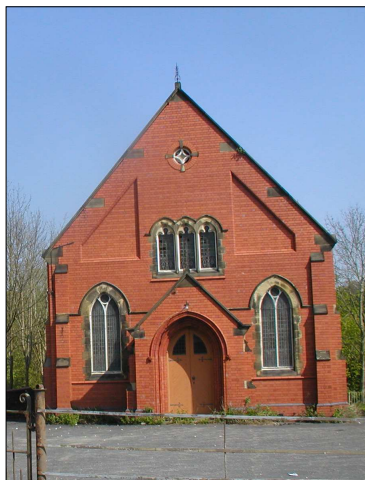
4.2 The redundant Y Groes Presbyterian Chapel occupies a large open site on the edge of the Conservation Area above Hill Street where the brightness of its Ruabon brick walls and large size contrasts to the diminutive scale and paint and render finishes of the nearby properties. The Chapel built originally

as the Calvinistic Methodist Chapel dates from the latter half of the 19th Century but has been extended and altered in the early 20th Century. Local sandstone detailing and pointed arched windows add to the buildings simple gothic inspired appearance. Surrounding the site to the roadside is a mixture of the original cast iron railings and smooth red brick walls.

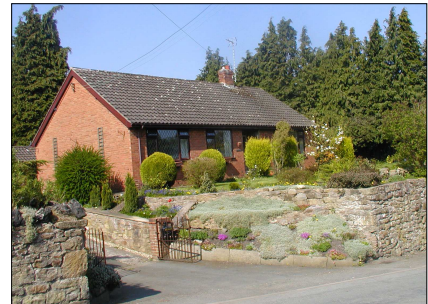
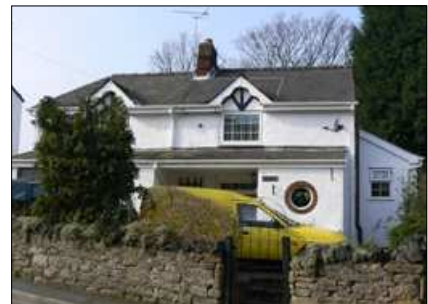
4.3 Continuing down into the valley, Hill Street is characterised by two storey buildings that follow the naturally steep gradient of the land and display painted and rendered facades. To the west the 20th Century properties of Mill View, Green Bank and Swyn Y Nant

are set into the hill slope behind traditional sandstone boundary walling the line of which marks the former route of Hill Street. A historic footway, accessed by worn sandstone steps and enclosed by high sandstone walls, remains between Green Bank and Swyn Y Nant connecting Hill Street to Chapel Street.

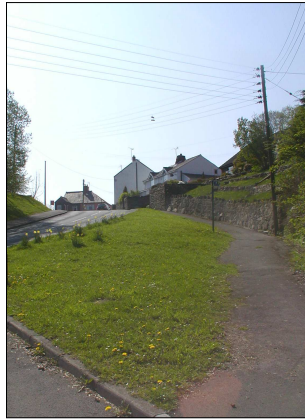
4.5 Sandstone walling continues as a common boundary to the west curving round the property known as River Bank, before extending north westwards along Lambpit Street. 'River Bank', positioned facing the junction of Hill Street and Lambpit Street, is a two storey stone cottage is one of the few historic buildings within the Conservation Area that displays the original stone façade. The property dates from the early half of the 19th Century and displays a date stone inscribed "J E S Jones 1826". Originally the building comprised two cottages however significant alterations and rebuilding of the front elevation has removed most evidence of the buildings original composition. The sandstone wall to the front is finished with worn 'cock and hen' copings with painted brick gate piers. To the left of the gateway a variation in the stone work may indicate the original access to the

second cottage. The property retains the traditional slate roof with modern rendered end chimney stacks.

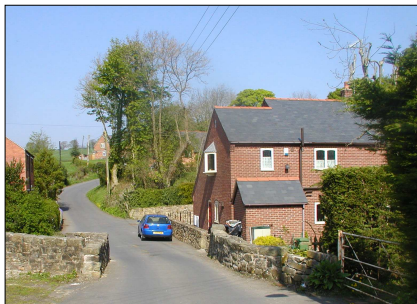
4.9 Immediately beyond the bridge and situated directly adjacent to Hill Street sits Nant-y-Crogfryn a two storey late 20th Century brick dwelling. The building occupies a peaceful location set behind a low brick wall

surmounted with metal railings and fronting the narrow cobbled track linking Lambpit Street to Mill Lane. The garden area of the property is enclosed to the north and south east by the two brooks which converge at the eastern end of the site. Detailing to the building is simple with painted timber windows and a traditional slate roof.

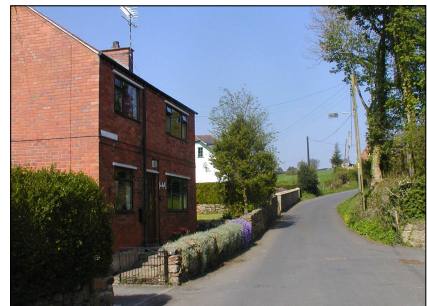
4.10 Facing the narrow cobbled track to Mill Lane is Number 1

Lambpit Street a late Victorian red brick dwelling. The building, set behind a characteristic sandstone wall, originally formed part of a row of two dwellings

with the second dwelling having been demolished during the 20th Century. The alteration and enlargement of the original openings has diminished the original appearance although the simple dentil course beneath the eaves and the traditional slate roof are retained.

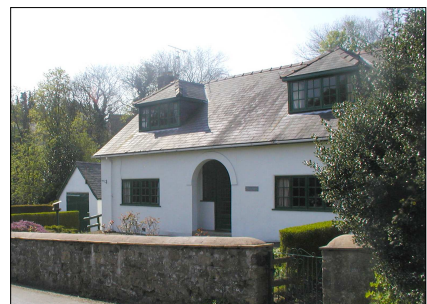
4.11 Continuing up the hill and set behind a characteristic sandstone boundary walling is Plas-y-Nant an attractive building of the interwar period, which

although quite different in character to the older, simple cottages in the village still adds to the sense of place of the Conservation Area due to good design, symmetry in the façade and the space around the building.

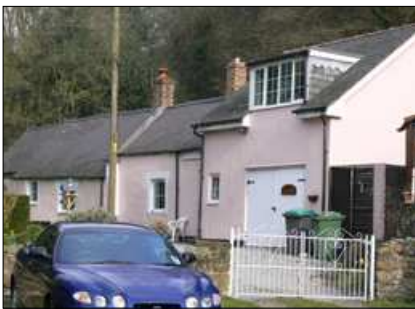
4.16 At the head of Mill Lane and set within large grounds is Nant-Y-Felin a 1½ storey painted rendered cottage with a traditional slate roof. The original part of the property is single storey and is said to have been used as a school. It is believed this section dates from the 18th Century, the uneven ridge line indicating it's age whilst adding to the character and charm of the building. The later larger extension is easily distinguishable and somewhat detracts from the traditional form. Windows are modern replacements within the original openings.

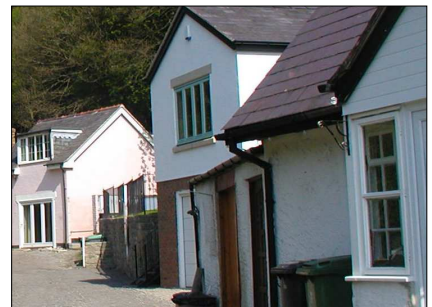
4.17 Adjacent and occupying an elevated position is

Cwm Afon, a modern two storey rendered building built into the hill slope behind a local yellow sandstone retaining wall.

The design of the building has incorporated simple detailing, such as gabled dormer windows and timber casement windows, from the surrounding dwellings helping it to integrate into the wider townscape.

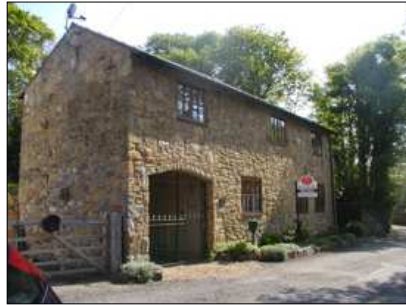
4.19 Adjacent is The Granary, an attractive yellow

sandstone building which is likely to be contemporary with the former Pentre Mill. The brightness of the sandstone offers a pleasing contrast to the modern cement render of the surrounding

buildings and gives the Granary a strong traditional character. The building was converted to residential uses in the later 20th Century and retains the arched cart entrance which adds interest to both the building and the street-scape.

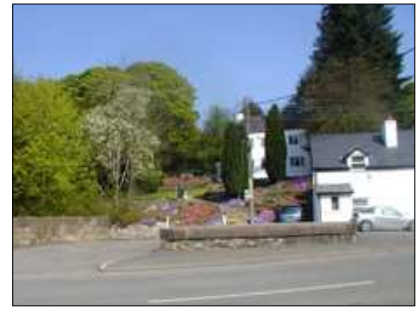
4.20 Moving towards the junction with Poplar Road, Mill Lane becomes enclosed by local sandstone boundary walls which line either side of the Lane.

Significant planting in the garden areas of 'Pen Y Bont' and 'Pentre View' further add to this sense of enclosure. Pentre View occupies an elevated position set back and above Mill Lane and within attractive grounds bounded by large trees. The property dates from the late 19th Century and originally comprised two dwellings however much of the original character has been lost through modern alterations to windows and doors and the application of modern cement render. A traditional slate roof and end stack remain on the building.

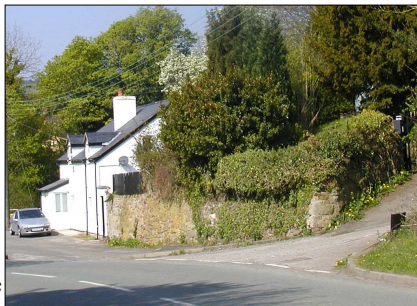
4.22 A sandstone wall extends from the side of Brookside forming a consistent boundary to the northern side of Poplar Road. Numbers 11 and 12 Poplar Road sit back from and above the highway with their position somewhat secluded by the large trees that line the site to the north.

The cottages date from the late 19th Century with the painted sandstone sills and end chimney stack being the only original detailing left visible on the façades. The cottages now comprise a single dwelling.

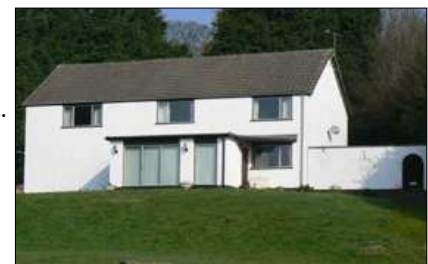
4.24 Continuing along the road the rural character of the area is strengthened by the presence of fields and native hedgerow boundaries which line the northern side. Looking south offers views towards Y Groes and the later 19th Century and 20th Century housing developments of Penycae. Number 10 Poplar Road sits on top a grassed verge within a large open site at the edge of the Conservation Area. The property incorporates an earlier building of late 19th century date known as

Berwyn View however modern extensions, alterations and materials have disguised the age and destroyed the traditional character of the building. The elevated, open location makes the property an unfortunate obvious feature within the wider views of the Conservation Area.

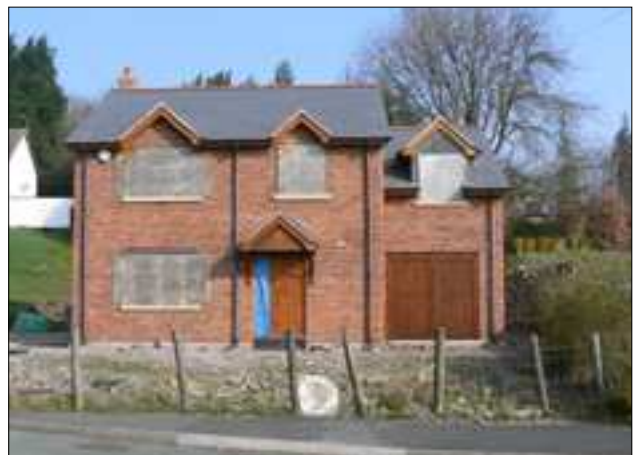
Number 9 Poplar Road

5.6 Planning permission for 9 Poplar Road was granted in 2002. The new dwelling has never been fully completed with the unfinished appearance and boarded up windows detracting significantly from the rural and tranquil appearance and character of the Conservation Area. The prominent roadside position unfortunately draws further attention to the building and sets a negative precedent for the rest of the Conservation Area.

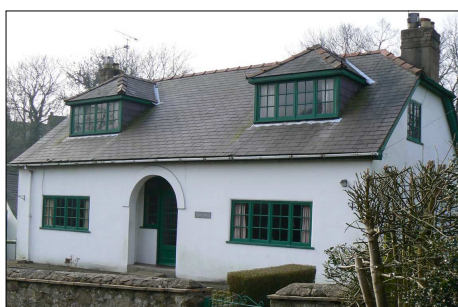
7.3 The roof line is nearly always a dominant feature of a building and retention of the original shape, pitch, verge and eaves detail and ornamentation is essential. Heights and shapes of roofs are important; flat roofs are alien to local tradition and are generally unacceptable. Chimney-stacks are important features of the roof-scape and should be retained even if no longer required. Where roofing materials are to be replaced they should match the colour, size and texture of the original. Roofs should be roofed or re-roofed in traditional materials on a like for like basis where historically appropriate. If ventilation of the void is required, this should be achieved by inconspicuous means; under eaves ventilation are acceptable, but visible roof vents are not.

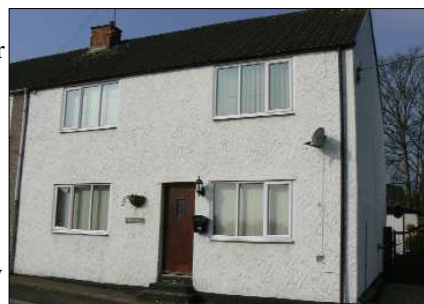
7.4 Any alteration or repair to external walls must respect the existing building materials and match them in texture, quality and colour. Every effort should be

made to retain or re-use facing brickwork or stonework, which must not be rendered, pebble-dashed or painted. Re-pointing should be carried out with a mortar to match the existing in colour, type and texture and historically would have consisted of lime and sand. Modern hard cement mortar and renders prevent the evaporation of moisture which can accumulate within the wall causing damp internally. When appropriate, hard cement renders should be replaced with a lime alternative.

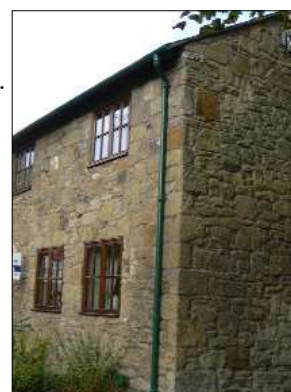
7.5 Rainwater goods should be repaired if original or reinstated in original materials. Plastic guttering is not appropriate on buildings within Conservation Areas. It is not historically correct, and it does not enhance a building's character. Cast iron guttering can last for a lifetime, if properly installed and maintained.

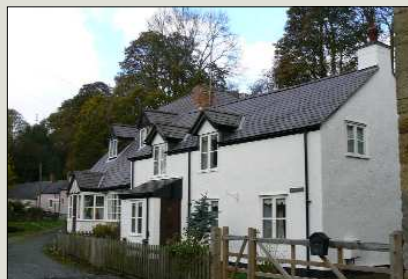
7.6 Windows are important features which should be correctly proportioned, well related to each other and adjoining buildings and should respect existing openings. Any repair or replacement should always match the original. This includes not only structural elements of the window but also the historic glass and original window furniture. Particularly important is the method of opening, the recessed depth within the reveal and the sections of glazing bars. Replacement of timber or iron windows in a PVCu alternative, no matter what the pattern, is unacceptable. All windows must have a traditional painted finish rather than a modern stained alternative.
