Ruabon Conservation Area Assessment and Management Plan

Adopted December 2010

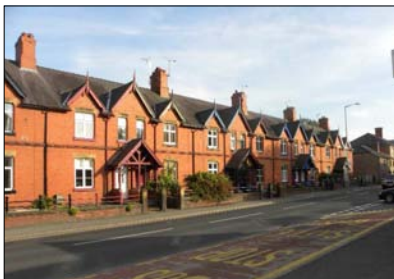
4.3 High Street is dominated by a series of steeply pitched gables and finials, forming the distinctive roof-scape of the terrace of Tai Clawdd. Built in 1888 by the Yorke family of Erddig, this was one of the earliest developments undertaken in the expansion of the village in the 19th century. The terrace provides a strong street frontage, the regularity of the elevations attributed by the gables giving rhythm to the street-scene. There are a total of 10 red brick-built properties in the row, comprising symmetrically coupled timber-framed porches and, at roof level, central gables

adjoined on either side by further smaller gablets. Some of the porches have been infilled. However, the original intention of the design can still be seen, in particular to numbers 2, 7 and 10 where all the original joinery, including windows and doors have been retained.

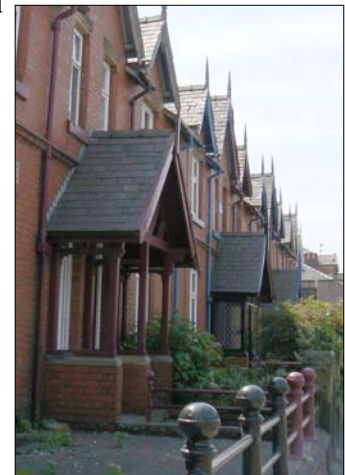
4.4 Whilst most of the original doors and windows have been removed, the buildings still display a certain quality in materials and details, in particular, the stone window heads and cills, tall corbelled brick chimney stacks, bargeboards and finials, terracotta stringcourse and boundary details. Tai Clawdd is fronted by small gardens enclosed behind smooth red brick dwarf walls which have stone copings surmounted by heavy iron railings with ball finials. The properties are accessed through substantial carved sandstone gate posts and simple metal gates which lead onto red and black tiled pathways and stone steps. Despite some minor alteration, the original design of the terrace is clearly evident and adds character and quality to the entrance of the Conservation Area.

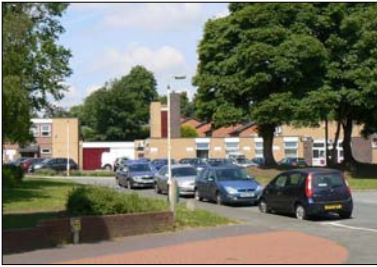
4.5 Tai Clawdd overlooks the site of the former Ruabon Accident Hospital, built in 1886 but later demolished, and now the site of late 20th Century Council offices, Ruabon Clinic and Ruabon Library.

Whilst there are some mature trees and areas of green space, the extensive parking on the site and the location of the toilet block immediately adjacent to the roadside greatly detract from the historic appearance of the area. To the west of the site can be seen the remains of a boundary stone wall.

ENHANCEMENT PROPOSALS	RESPONSIBLE BODY
High Street Public Toilets - Should the opportunity arise in the future the public toilets should be relocated to a more discreet location.	WCBC - Environment Department
Vulnerable or vacant buildings - Mount House, Mary's Salon, Ruabon Station, numbers 1-4 Grenville Terrace and Providence Chapel are buildings that could become buildings at risk if their condition is allowed to deteriorate. Contact will be made with owners of these properties to establish a way forward and investigations made into potential for grant assistance.	Private Land-owner
Repair and reinstatement of Building facades to Park Street - There will be continued investigation into possible sources of grant aid in order to further assist in the restoration of the street-scene.	Private Land-owner
Stone Walls form an important boundary treatment that add significantly to the character of the Conservation Area and would benefit from a comprehensive scheme of repair.	Private Land-owner

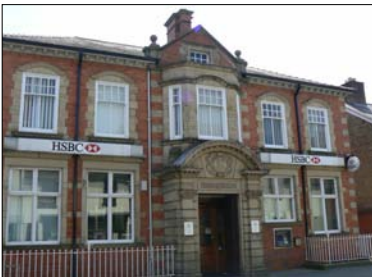
4.6 Continuing into the centre of the village, after Tai Clawdd are numbers 12 and 13 High Street, a pair of stone built cottages which sit directly onto the footpath and believed to have been the former tollhouses. The former North and South Wales Bank (now the HSBC Bank) stands on the left side of the street. It is a building of considerable quality and status that was built around a similar time to Tai Clawdd. It is set back from the road behind a low stone

plinth inset with fine iron railings. The building is constructed of smooth red brick with a hipped slate roof, central brick stack and sandstone dressings. It consists of 5 bays, the central bay comprising of a grand, rusticated stone porch with open segmental pediment, canted bay at first floor and coped pediment to the second floor. The building largely retains its original joinery, with tall casement and sash windows to the ground and first floors.

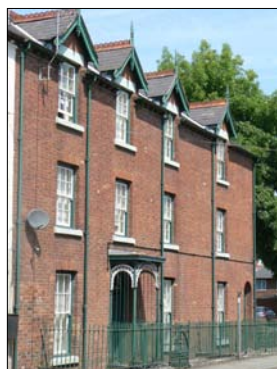
4.7 On the opposite side of the road is an impressive pair of former dwellings of the Georgian period, Bryn End. A small enclosed area to the front set behind fine iron railings and separating the building from the road gives a clear indication of the greater importance and status held by the properties during earlier times. The building is constructed of red brick and is 3 storeys in height with finial adorned dormers set within the eaves. These appear to have been a later addition, built in smooth red brick. To the ground and first floors, windows have flat arched heads and stone sills and doorways with semi-circular heads. Windows are all traditional 12 paned

sliding sashes and the left-hand property retains its original porch. The height of the building and regularity of the dormers and fenestration continue to add to the rhythm and strong vertical emphasis of the streetscape and creates a striking and imposing group within the street-scene. The age and authenticity of the façade make this a landmark building within the village.

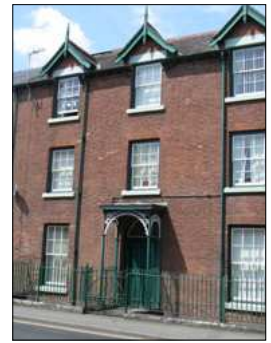
4.8 The adjacent building has been much altered; originally it was gable fronted and half-timbered with a jettied bay to the first floor, providing a significant frontage within the street. The bay has now been replaced with a wide single window which displays a horizontal emphasis and unbalances the proportions and upsets the rhythm of the streetscene. Adjacent is a much lower 2-storey building, the contrasting heights making for an interesting street-scape. This property retains its sliding sash windows to its upper floors but the original shop front has been replaced. The façade of the neighbouring building is of a design completely out of character with others in the Conservation Area. Ironically, this replaced the former Head Office Building of Dennis Ruabon, an ornate building which displayed fine decorative terracotta detail serving as an advertisement for the products available from the nearby clayworks. The replacement structure regrettably is rendered at ground floor level with small irregular window openings throughout. The relationship of solid wall to void fails to respect the quality of design, proportions and rhythm so characteristic of this part of High Street. The adjacent 2 - storey properties display similar undesirable characteristics.

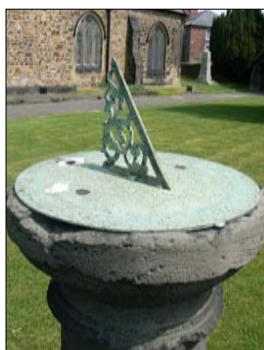
4.11 The Church of St Mary is a Grade I Listed Building. It is of mediaeval origins but has been extensively remodelled. It is built of sandstone rubble and ashlar and has a 4 stage 14th Century tower. The windows mostly date from the 19th Century and are in the perpendicular style. The structure comprises gabled aisles with a clerestoried 5 bay nave. Internally exists a 15th Century wall painting and many fine furnishings and monuments. The Churchyard is enclosed by a rubble stone wall and contains a grade II listed sun-dial and many mature trees. It is a

significant and tranquil area of open green space at the heart of the Conservation Area that provides a natural backdrop to the village and enhances the setting of many buildings. The lychgate was built after the Great War to commemorate those who fell. It opens onto the junction with High Street and Church Street, an important convergence point that is enclosed by a significant composition of important buildings comprising, the Church, the Wynnstay Arms Hotel and Mary's Salon and Wynnstay Mews.

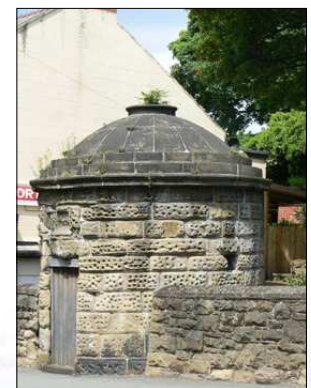
enhanced by the appearance of the Round House, nestled below the substantial Churchyard walls. The Round House, a grade II listed building is a distinctive landmark within the village. It was built in the late 18th century as a parish lock-up and is constructed of sandstone blocks with a domed roof and small openings with iron bars. From this point the road rises and curves back up into the centre of the village, the great churchyard wall on the left, framing the view of the Wynnstay Arms immediately ahead.

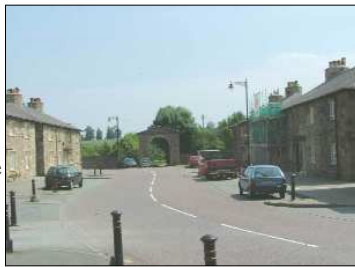
4.25 The architect John Jones designed the gateway in 1783, replacing earlier lodges. The great tree-lined avenue beyond has now been dissected by the slip road to the A483, making the gateway redundant. The archway is built of local Cefn sandstone with wrought iron gates and railings erected in 1912 to mark the coming of age of the 8th Baronet, Sir Watkins Williams-Wynn.

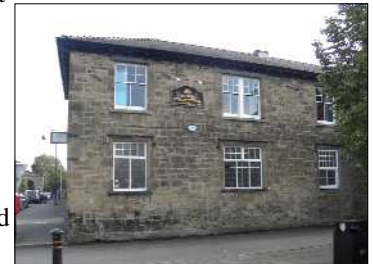
4.26 The cottages and gate lodge are 2 storey buildings with hipped slate roofs and overhanging eaves. They are constructed from squared sandstone rubble and dressed quoins and have squat octagonal chimney stacks. The cottages have paired central entrance doors

to the front with a further entrance to each gable under stone canopies. Many of the windows have been renewed with traditional multi-paned casements under stone hoodmoulds. At the north west end of the street is the stone-built Constitutional Club, formerly the Village Room, adjacent which was once The Goat Inn and an area of open space known as the Goat Bank where fairs and markets were held.

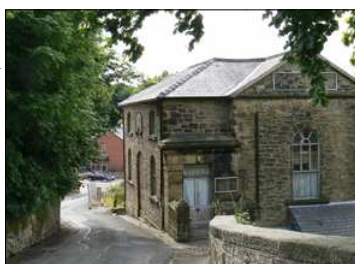
4.30 The Rhagluniaeth or Providence Chapel, which opened in 1834, was built on land which belonged to Sir Watkin Williams-Wynn and the architect Sir Benjamin Gummow provided his services for the Chapel without charge. It is a prominent building at the entrance to the Tan y Llan

built of random sandstone with a hipped roof and a pedimented gable to one side and tall windows with semi-circular heads. Unfortunately, the site behind the chapel has become overgrown and the boundary wall has been lost.

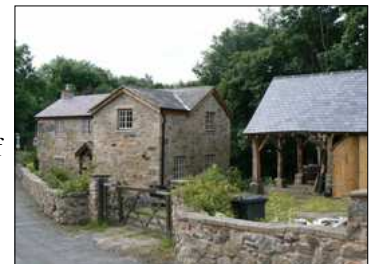
4.31 At the bottom of the hill just before reaching the bridge is the Rhuddallt Mill, meaning 'red cliff'.

Built as a mill on the banks of the river, it has been sensitively converted to a dwelling in recent years. It is constructed of random sandstone with a slate roof. The joinery details have been renewed in a traditional style. To its frontage is a low stone wall which continues around a sharp bend and connects with the bridge.

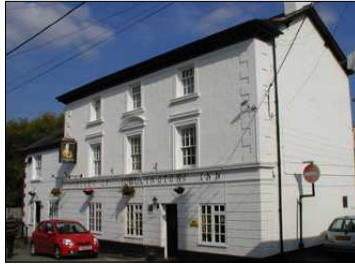
4.35 At the corner of Paddock Row with Duke Street is the Duke of Wellington Public House. The main body of the building is of 3 storeys in height and 3 bays wide. It has a pebble-dashed finish with details such as architrave's and quoins picked out in smooth render. The upper floors retain sliding sash windows. Opposite is a terrace of small 2 storey cottages, these have been rendered and

their original openings altered. To the right of the public house is Wynnstay Court a modern development of apartments within 2-3-storey buildings built in brick with hipped slate roofs.

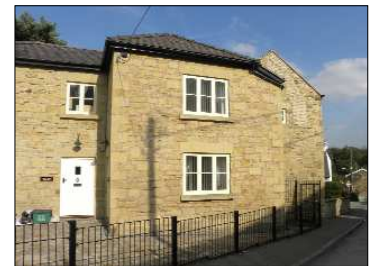
4.36 The junction of Paddock Row with Bridge Street facing Station Road is marked by the distinctive Old Bakery and Apple Bank on the east and the Park Road Methodist Chapel to the west. Apple Bank and the Old Bakery are a pair of dwellings built of random stone with dressed stone quoins which formerly served as shops and have been sensitively converted. The Old Bakery has a hipped roof, a common feature within the Conservation Area.

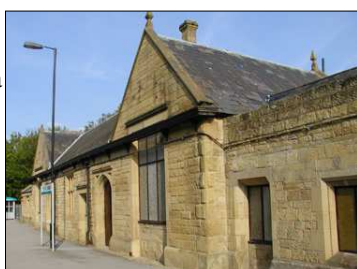
4.39 Ruabon Station is framed by trees and hedges and enclosed by a backdrop of trees beyond the station platforms. The present building was constructed in the 1860's to the design of Henry Robertson, replacing the original station designed by T.M. Penson. It is built in the Tudor Gothic Revival style of sandstone ashlar with rusticated quoins, stone chimney stacks and mullioned and transomed windows. Each end of the building has a projecting gabled wing, the right hand wing terminating the view from Station Road. The building has been used for offices in recent years but is presently vacant. Running parallel with Station Road from its junction with Bridge Street are four detached late 20th Century red brick dwellings designed in an appropriate scale and materials for their surroundings.

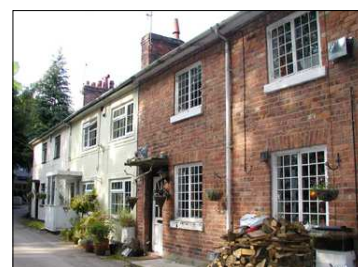
4.40 Set below the station and on the opposite side of the river is Railway Terrace, comprising two blocks of

four cottages dating from the mid 19th Century. Built of brick with hipped, slate roofs with brick chimney stacks, each elevation consists of two windows to each floor with an offset door under a flat stone canopy. Most of the properties have now been altered with render or paintwork applied to the brickwork face and original doors and windows replaced in modern alternatives.

However, numbers 2 and 6 of the Terrace still display their original characteristics and retain multi-paned iron casement windows. The properties of Railway Terrace are positioned directly onto the road which is lined by a combination of stone walls with flat stone copings and hedgerows running adjacent the Afon Eitha and its wooded banks which together provide a strong sense of enclosure and rural character similar to that of Tan-y-Llan.

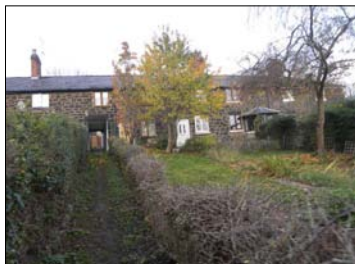
4.43 Positioned on an elevated site above Pont Adam is Mount Pleasant which dates from the mid 19th century. The terrace comprises of 10 random stone built cottages with hipped slate roofs and brick chimney stacks, some with decorative chimney pots. Most of the original door and window details have been lost, although multi-paned iron casement windows remain to the ground floor of Number 1. The gardens stretch out to the front of each property mostly sub-divided by hedgerows which create a softer appearance in contrast to heavy stone façade of the terrace. The garden of Number 1 Mount Pleasant is enclosed by a stone wall with pyramidal copings.

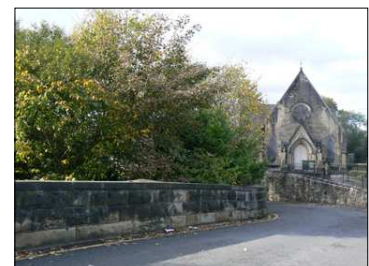
4.46 The Hill Street Congregational Church sits on an elevated position above Pont Adam, its churchyard enclosed by a high stone wall running alongside the road. This grade II listed church was built in 1857-8 to the design of W.I Mason of Liverpool. It is built in Gothic Revival style of roughly coursed and squared sandstone rubble with ashlar dressings and has a schoolroom attached to the rear. Its steeply pitched gabled frontage is a prominent feature on the approach towards Pont Adam.

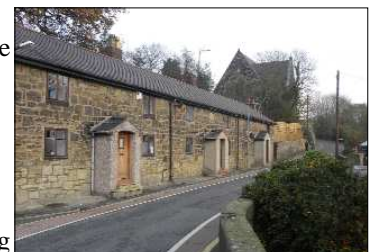
4.47 The Churchyard wall tightly bounds the road steeply descending until it meets with the stone cottages of 1-3 Pont Adam to give continuity and a strong

street frontage. The cottages have hipped slate roofs and 2 windows to each floor symmetrically placed about a central doorway behind more recently constructed porches finished in a lined-out render. Centrally positioned to the first floor of the central cottage is a plaque engraved with 'WWW', the initials of Sir Watkin Williams-Wynn.

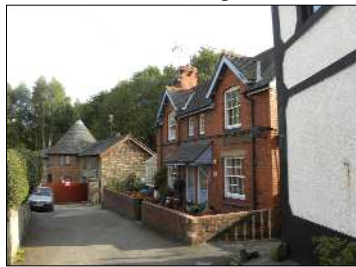
4.48 Immediately opposite the cottages, a narrow lane leads down to Brookside, an unusual but visually attractive structure built on the site of the former gasworks. It consists of two stonework end wings positioned about a semi-circular central brick bay with a decorative conical roof. The stone element to the right of the brick bay is the older part of the building the remainder dates from the late 20th century. The nearby footpath which leads to the footbridge across the railway line runs alongside a waterfall, upstream amid woodland.

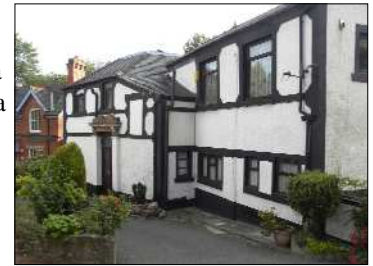
4.49 1 and 2 Nant-y-Gwalia cottages sit behind a brick wall to the left side of the Pont Adam. These dwellings date from the late 19th century and are built of smooth red brick with slate roofs, corbelled brick chimney stacks and 12 paned sash windows to each floor, those to the first floor under gables. The front doors are paired together under a shared canopy. Both cottages retain their original character. Adjacent lies the former Nant Public House, a substantial rendered property painted white

with detail such as architraves picked out in black, in similar style to that of number 4 Pont Adam immediately opposite. The impressive doorway is perhaps the only remaining clue to the Nant's former use as a Public House: it has a flat stone hood with scrollwork above carried on stone consoles upon pillars. Within this area, the variety of materials, and diversity of building styles so compactly sited creates a most varied and interesting streetscape.

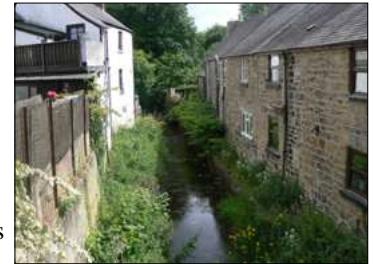
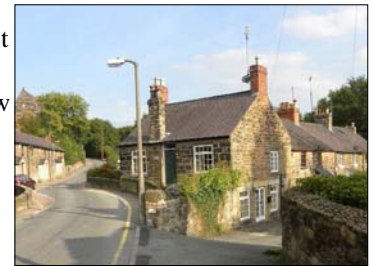
4.50 Downstream from the bridge the Afon Eitha is tightly bounded on both sides by the properties of West End Terrace and the former Nant. West End Terrace consists of 5 cottages set below road level. Number 1 is orientated towards the road and is accessed at first floor level. The terrace is constructed of random sandstone rubble with stone quoins and slate roof. Openings have stone lintels and sills but unfortunately all the original joinery details have been replaced. Gardens are located opposite and enclosed by hedgerow and a remaining stone wall with cock and hen coping.

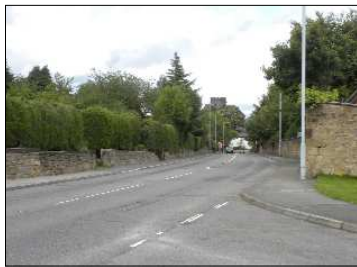
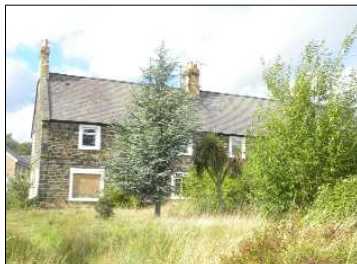
4.51 Sandstone boundary walls mark the entrance into the Conservation Area from the south west along the B5605. Evident on both sides of the road, the walls lead the eye towards the village centre, the view terminated by the church tower rising above the village with mature trees in its foreground. The walls to the south side of the road originally served as a boundary wall to the Wynnstay Estate and are further evidence of the importance of the estate in the development of the settlement. Set beyond the walls, trees and dense

foliage provide a pleasant approach into the village and create a distinction between the more densely developed housing estates on the periphery of the village and the more historic core.
